RAPHO TOWNSHIP
 971 North Colebrook Road
 Manheim, PA 17545
 Lancaster County

ACT 537 SEWERAGE FACILITIES PLAN
Inventory of OLDS & Private Wells
Map 3
 Prepared by **ARRG**

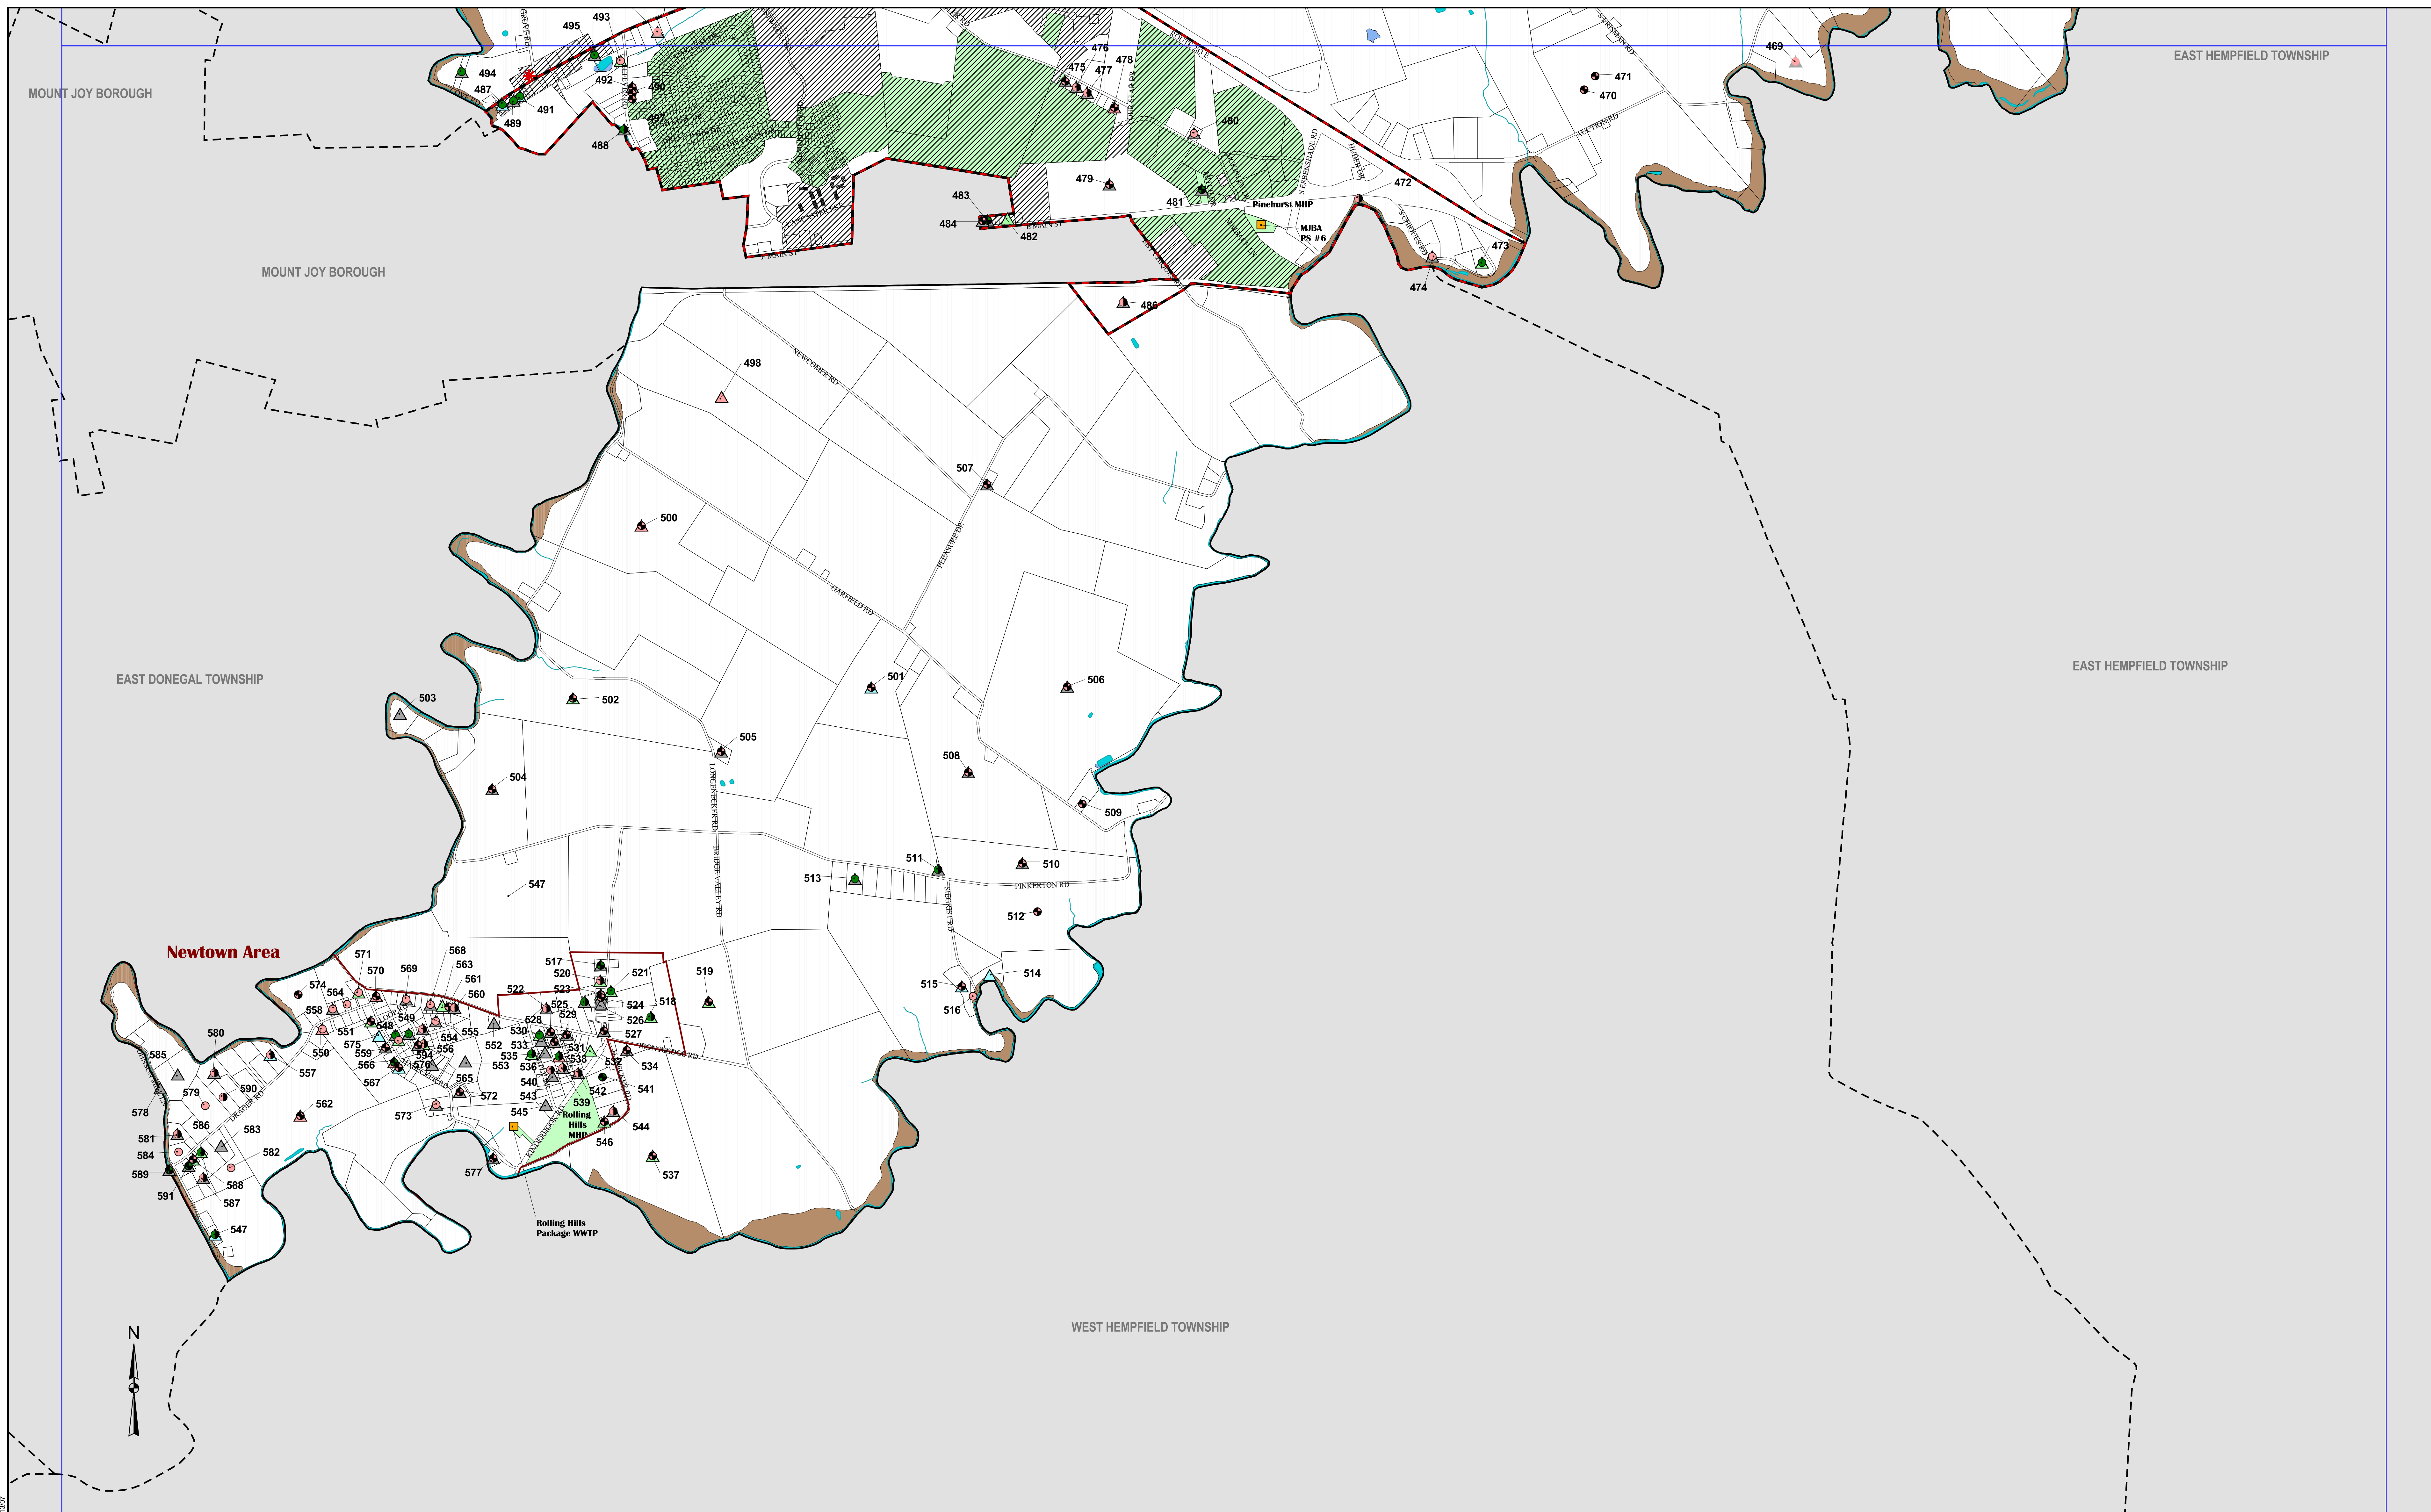
WELL RESULTS

- Wells with no Bacteria Detected and Nitrate Levels < 5 mg/l
- Wells with no Bacteria Detected and Nitrate Levels 5-10 mg/l
- Potential Malfunction Wells with no Bacteria Detected and Nitrate Levels > 10 mg/l
- Wells with Bacteria Detected and Nitrate Levels < 5 mg/l
- Wells with Bacteria Detected and Nitrate Levels 5-10 mg/l
- Potential Malfunction Wells with Bacteria Detected and Nitrate Levels > 10 mg/l

SANITARY SURVEY RESULTS

- Confirmed Malfunction
- Suspected Malfunction
- Potential Malfunction
- No Detected Malfunction
